# Smoke and Dye Testing Summary

## High Level Sewershed

Test ID	Test Type	Date Inspected	Company / Super.	Blower MH	Ground Condition	Notification Made?	Total Length
S1028-077	Smoke	9/10/2008	ADS/TM	S13AA1021MH	Dry	Yes	623.89

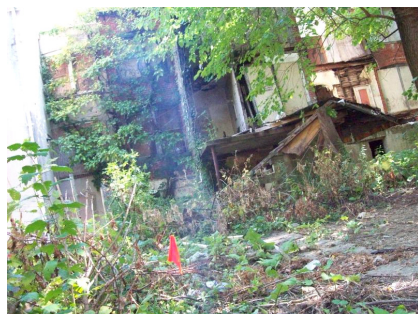
**Picture** \S1028-077-OB01-P01.jpg

**Source** Cleanout

**Location** Yard - back

**Comments** Smoke from cleanout in back yard. 3710 Towanda Ave.

**Comments** Back of house, 3710 Towanda Ave.

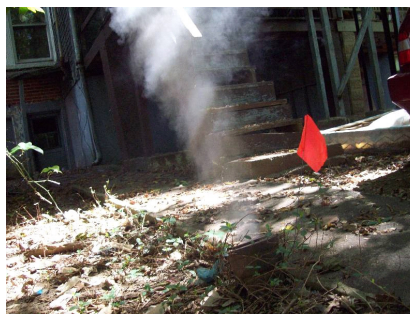
**Picture** \S1028-077-OB02-P01.jpg

**Source** Cleanout

**Location** Yard - back

**Comments** Smoke from cleanout in back yard. 3718 Towanda Ave.

**Comments** Back of house, 3718 Towanda Ave.

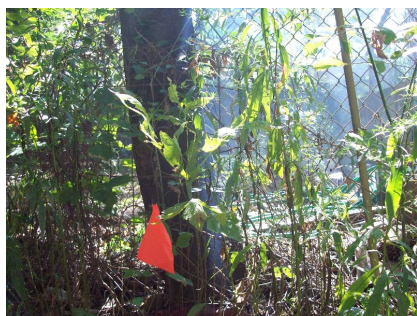
**Picture** \S1028-077-OB03-P01.jpg

**Source** Cleanout

**Location** Yard - back

**Comments** Smoke from cleanout in back yard. 3714 Towanda Ave.

**Comments** Back of house, 3714 Towanda Ave.

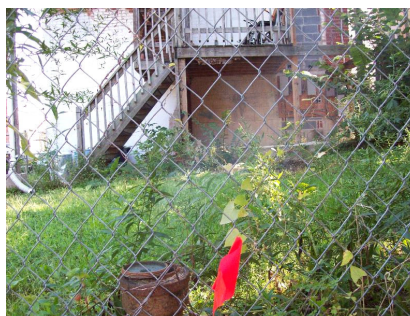
**Picture** \S1028-077-OB04-P01.jpg

**Source** Cleanout

**Location** Yard - back

**Comments** Smoke from cleanout in back yard. 3738 Towanda Ave.

**Comments** Back of house, 3738 Towanda Ave.
